Mazinaw Lake Shoreline Assessment Summary Report

Submitted by Watersheds Canada and the Canadian Wildlife Federation.

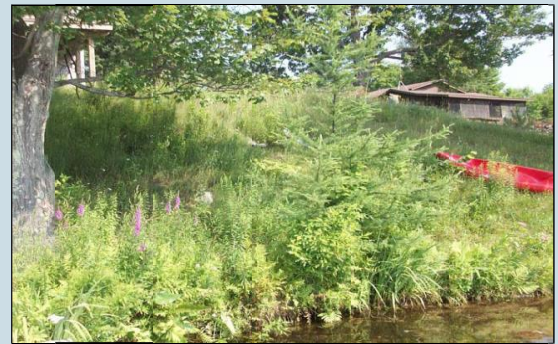
Regenerative – Natural vegetation has been removed in the past, but is in the process of growing back towards a natural state.

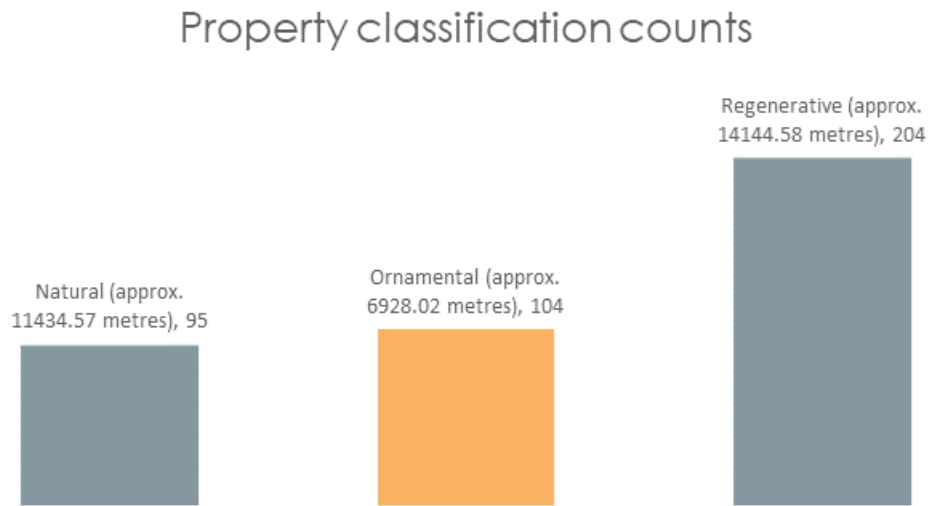
Figure 1 Property Classifications

Figure 1 shows the counts of property classifications on the lake. For example, a property that was 60% Natural, 20% Ornamental and 20% Regenerative would be classified as Natural. Alternatively, a property that was classified as 40% Ornamental, 30% Regenerative and 30% Natural would be classified as Ornamental.

On Mazinaw Lake, 95 shoreline properties were classified as majority natural, 104 majority ornamental and 204 were considered majority regenerative. It is recommended that shoreline property owners engage in naturalization projects to further decrease the ornamental percentage and increase the regenerative and natural percentages.

This presents an opportunity for residents of Mazinaw Lake to increase the overall quality of the lake by maintaining, protecting and enhancing natural shorelines. To restore shorelines to a more natural state, property owners are encouraged to take action. Regenerative properties should also be encouraged to maintain their properties in a natural state by allowing the vegetation on their property to continue to regenerate and grow naturally.

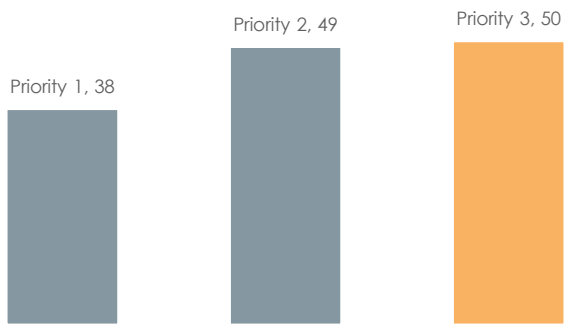
Figure 3 Shoreline Naturalization Property Rankings

Please note that 30m difficult is checked off during the assessment when it is difficult to create or expand an existing buffer. Limitations may be caused by the close proximity of a structure, cliff, rocky terrain/bedrock, or other factors that would make planting a buffer difficult.

In order to determine restoration opportunities on the lake, properties that were assigned a recommendation to expand or create a vegetated buffer were identified and ranked according to their potential for restoration as follows.

Currently 137 properties would benefit from shoreline naturalization. Of these 137 properties, 38 or 28% of properties are a top priority.

Shoreline naturalization is a voluntary action by landowners. While naturalization of the more ornamental or degraded properties may produce greater benefits, increasing the natural shoreline on any property is a positive stewardship action.

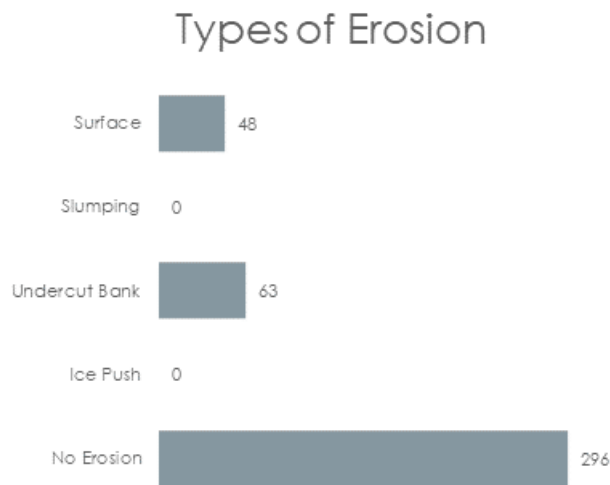
Figure 4 Types of Erosion

Figure 4 shows the counts for each type of erosion data that was collected on Mazinaw Lake

There are a number of steps that can be taken to protect Mazinaw Lake. Protect the natural shoreline by planting or maintaining native vegetation and leaving in place stones, boulders, snags and dead branches found along the shoreline, when it is safe to do so. Reduce runoff by maintaining native vegetative buffers and have rain barrels to collect runoff from roofs. Also, minimize wake from boats, take precautions during construction and use pathways and stairs to limit foot traffic to the shoreline.

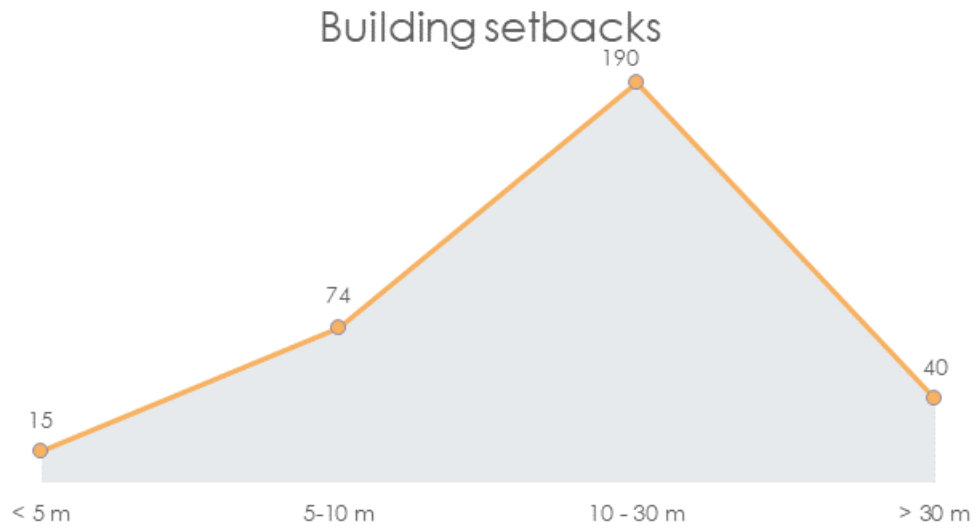
Figure 5 Building Setback Ranges

Shown in Figure 5 is the range of building setbacks for properties on the lake, not including vacant properties, buildings under construction and unidentifiable properties. Building setbacks for shoreline developments in Ontario should be at least 30 metres from the high water mark; however, older cottage buildings were

permitted closer to the high water mark. On Mazinaw Lake, 69% of the properties surveyed were observed to be closer than 30 metres to the shoreline.

A potential area of concern with building setbacks is having septic systems installed close to shore. Regular inspections and maintenance of septic systems can help prevent excess nutrients from entering the lake. Nutrients entering the lake can contribute to eutrophication, resulting in increased aquatic vegetation, low oxygen levels, turbid water and algal blooms. Excess nutrient loading is one of the largest threats to water quality in lakes and rivers; it is everyone’s responsibility to do something to help protect the lake.

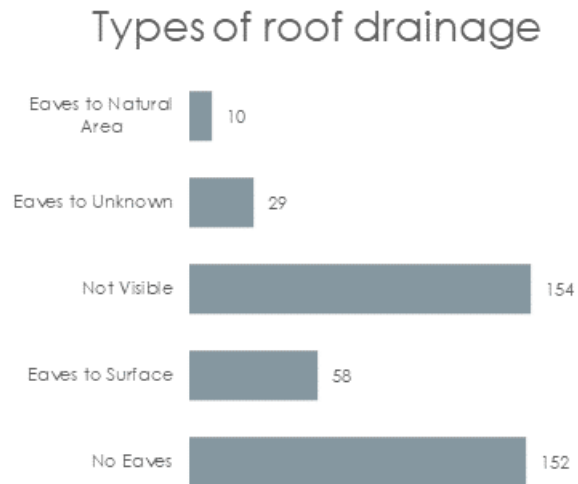
Figure 6 Roof Drainage types around lake

Naturalizing shorelines on properties with near-shore building setbacks would help reduce runoff from entering into Mazinaw Lake, which could help reduce potential problems such as algae blooms and loss of oxygen in the water. Property owners can also manage this problem by ensuring they have eave troughs with downspouts directed at natural or stone catch basins or rain barrels, as well as ensuring they have a properly functioning septic to process wastewater before it enters the lake. It is also important to use phosphate free products. Figure 6 shows the types of roof drainage that were recorded from the shoreline assessments.

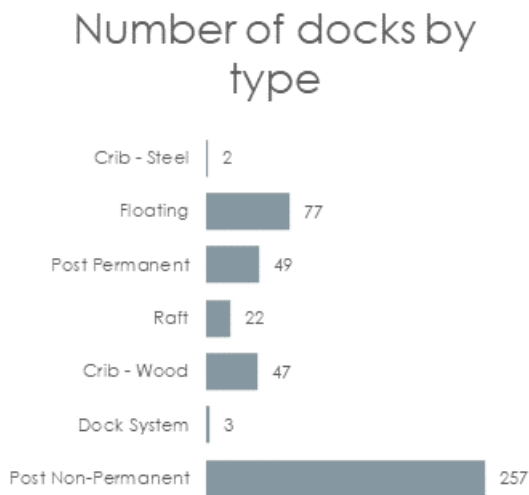
Figure 7 Docks On Lake

Shoreline development is defined as the presence of man-made structures in the water or along the shoreline within three metres of the shore. Development along a shoreline can be done sustainably and in an environmentally sensitive fashion, providing structures are well maintained and kept to a minimal footprint. Figure 7 and 8 illustrate the common structures present on Mazinaw Lake.

Floating docks, post docks and cantilever docks are the most environmentally friendly choices, they allow natural water flow, have limited contact with the lake bottom, and reduce the overall potential for disturbance to aquatic life.

In the future, if shoreline property owners need to replace their old or failing solid or crib docks, they could consider choosing post, cantilever or floating docks. By selecting these types of docks, people can reduce the

potential impacts to fish and other aquatic species, which can help protect the overall health of the lake environment.

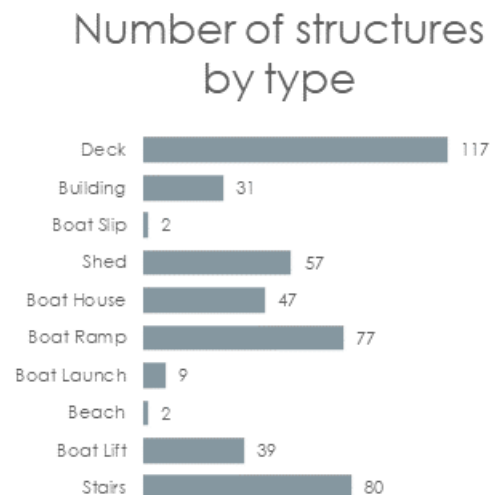
Figure 8 Structures on Lake

On average property owners have developed 21% of their shoreline within a few metres of the water's edge. Different types of structures can have negative environmental impacts, due to their ability to remove habitat, store contaminants and nutrients, and eventually release them into the aquatic environment.

When shoreline development structures are present, keep structures clean and organized to prevent possible soil and water contamination. Consider planting native species to provide additional habitat between man-made structures and the shoreline. If an older structure is present and no longer functioning, consider retiring the building, shed or other man-made structure, this will provide more habitat potential for wildlife.

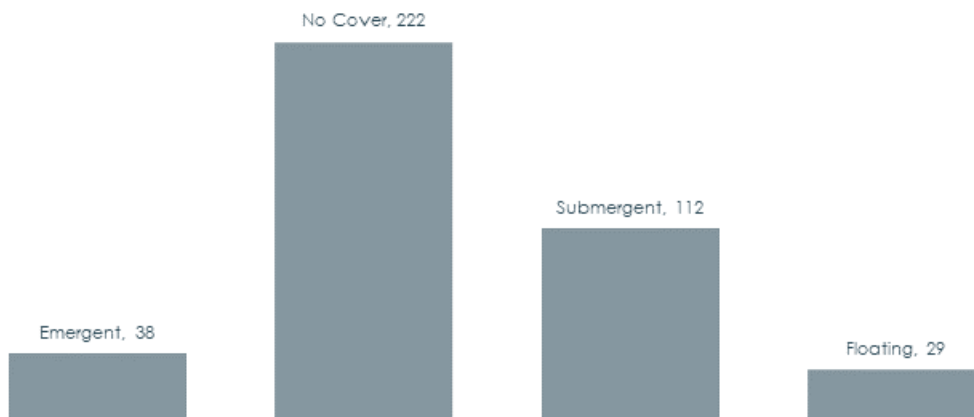
Figure 10 Aquatic Vegetation

On Mazinaw Lake, shorelines were surveyed for their presence of aquatic plants. The presence of aquatic plants was further summarized into aquatic vegetation types; emergent, submergent, floating and algal blooms. Figure 10 shows the number of properties on Mazinaw Lake that had aquatic plants along their shoreline properties. The majority of aquatic vegetation that was present on Mazinaw Lake was categorized as submergent vegetation. Emergent vegetation and floating vegetation were found less frequently on Mazinaw Lake, but are still an important part of the aquatic ecosystem; giving habitat to birds, frogs, dragonflies and other wildlife.

When aquatic vegetation is removed, the integrity of the shoreline is lost. This negatively impacts the health of the waterbody by decreasing the quality of the water and reducing biodiversity. Eventually, a waterbody can become unusable, affecting the hundreds of species that rely on it. Fortunately, there are some easy steps that can be taken to help protect and restore your shoreline. By planting native species and allowing natural aquatic vegetation to grow, you can help provide habitat for wildlife to flourish.

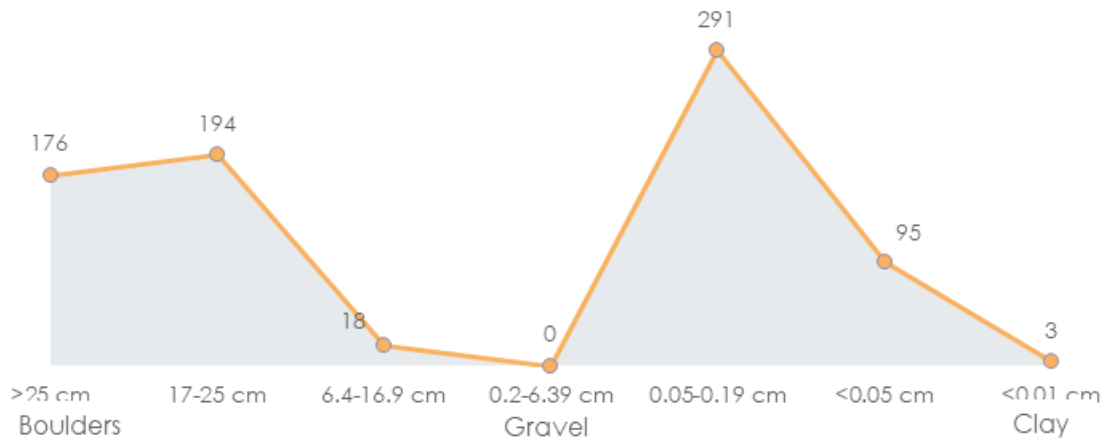
Figure 11 Sediment Distribution

On Mazinaw Lake, the type of sediment present on the lake bottom was observed. The benthic zone which is located on the lake bottom is classified as the ecological region at the lowest level of a body of water. It starts at the shoreline and continues down until it reaches the floor, encompassing the sediment surface and subsurface layers. Although this zone may appear barren, it plays a vital role in the health of aquatic ecosystems. Tiny, microscopic organisms which cycle nutrients live in this zone and act as a source of food for bottom feeding animals.
